Continued from "Bogus Beryllium" (Sept. '04 VC, p. 24).

By Mike Klasco and John Schaffer  
Bogus Beryllium

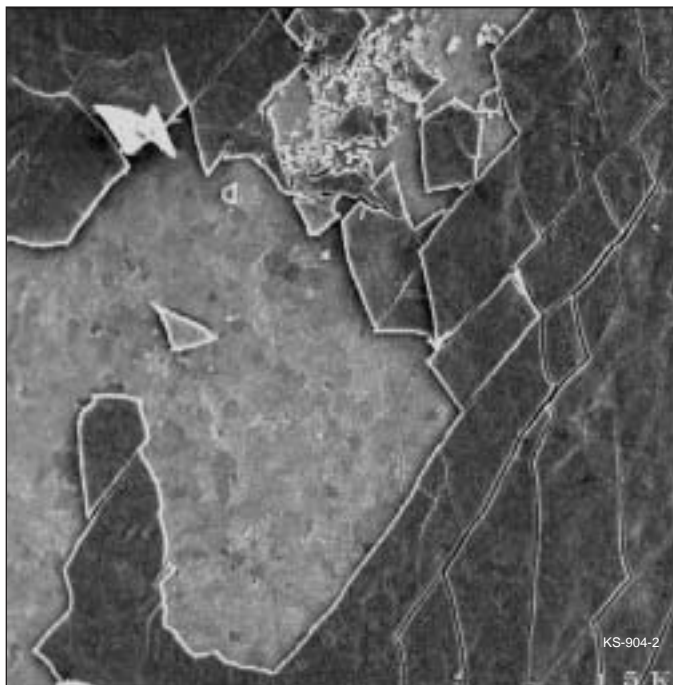
The SEM image in *Fig. 2* shows two major areas. There is the dark coating that is flaking off and a lighter colored surface that is mottled underneath. EDXA spectra using 10kV beam voltage show only titanium peaks for both areas (*Fig. 3*).

FIGURE 2: SEM image of 1" cone surface showing flaking coating and material underneath.

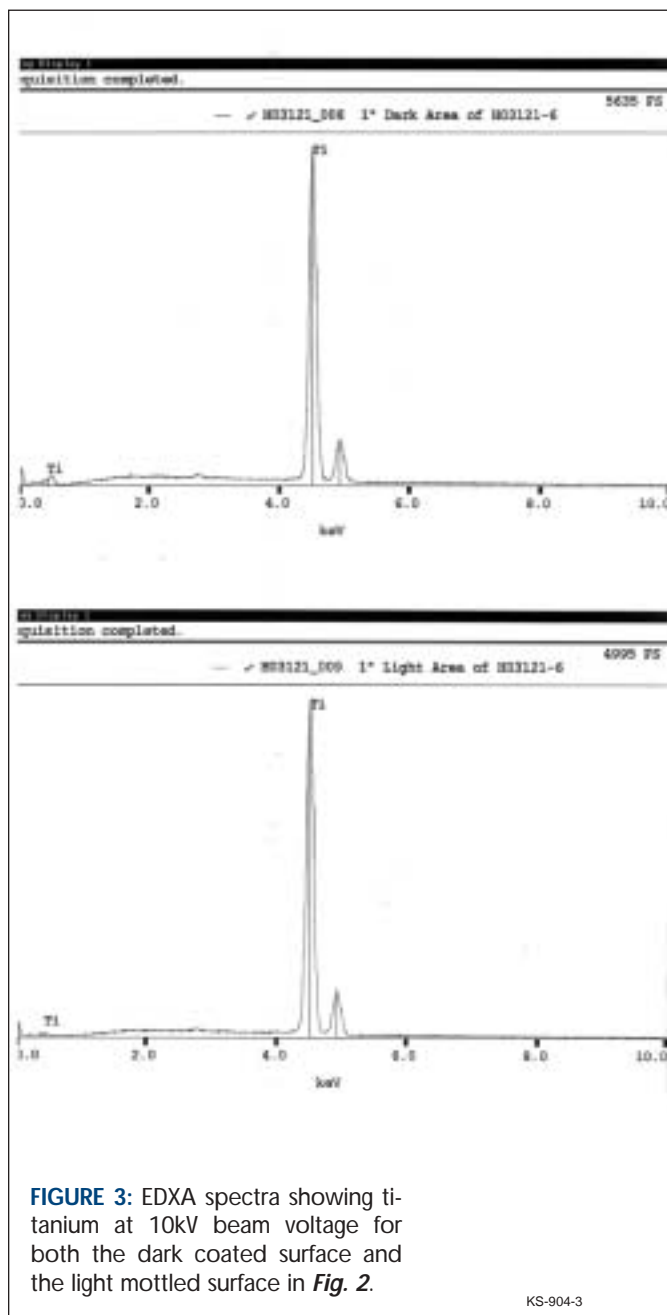
KS-904-3

FIGURE 3: EDXA spectra showing titanium at 10kV beam voltage for both the dark coated surface and the light mottled surface in *Fig. 2*.

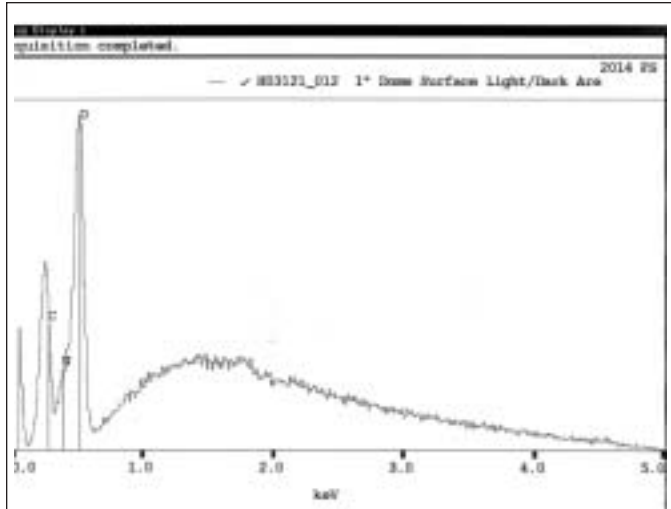
KS-904-4A

The dark coated area had very high oxygen content, suggesting the coating was a paint containing oxide (probably  $TiO_2$ ) as an opaquing agent (*Fig. 4A*). The spectra for the light area within the light mottled area had the lowest signal-to-noise ratio, suggesting this was the "metal surface" (*Fig. 4B*). These results show titanium's strength as an oxide, carbide, and nitride former. The dark areas within the mottled area appear to be different than the coat surface, although both areas have high oxygen peaks (*Figs. 4A and 4C*). The oxygen to carbon ratio appears to be different for the two spectra.

**FIGURE 4A:** EDXA spectra for dark area of the light mottled area in *Fig. 2*, showing high oxygen content.

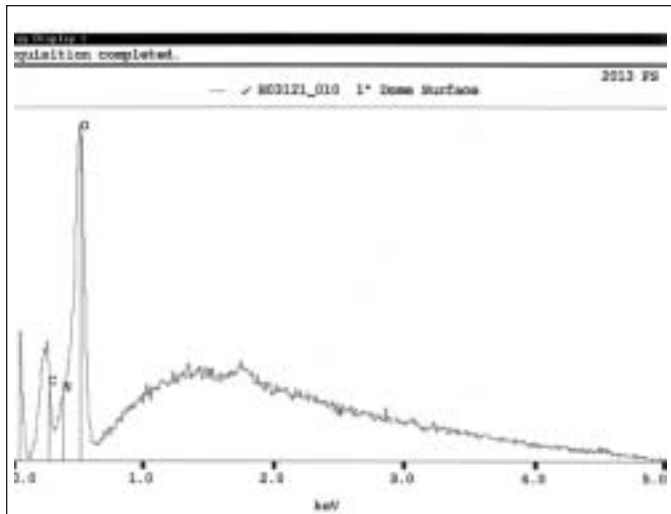
KS-904-4B

**FIGURE 4B:** Light area of the light mottled area in *Fig. 2*.

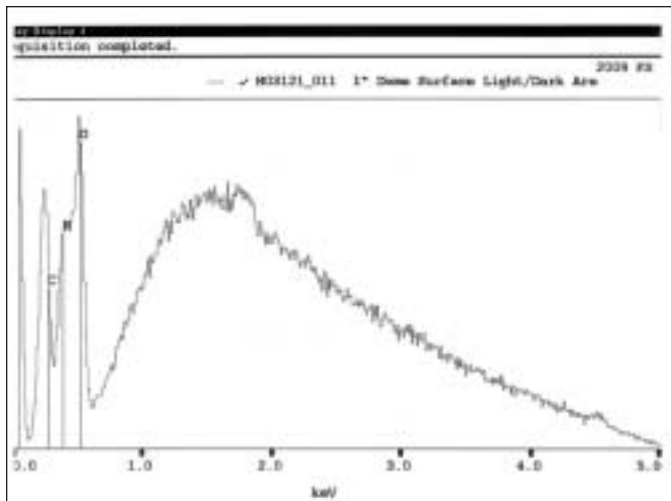
KS-904-4C

**FIGURE 4C:** Dark area of the light mottled area in *Fig. 2*.

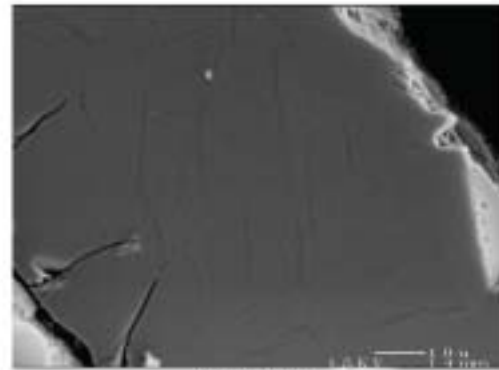
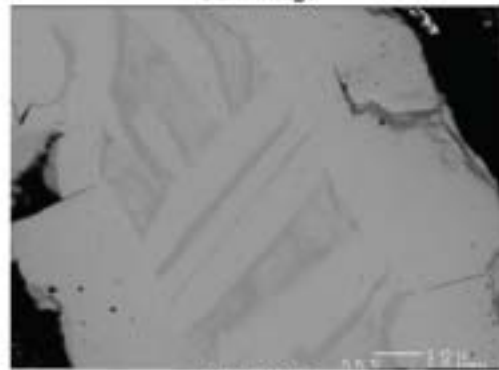
KS-904-5

*Fig. 5* shows microstructural features of the polished cross section of the 4½" dome. The two outer layers appear featureless while grain structure is apparent in the middle. The "color" of the cross section suggests all areas have a very similar atomic weight and are very likely to be the same material. Cracks appear to be contained only in the featureless outer layers.

**FIGURE 5:** 4 1/2" dome cross section images.

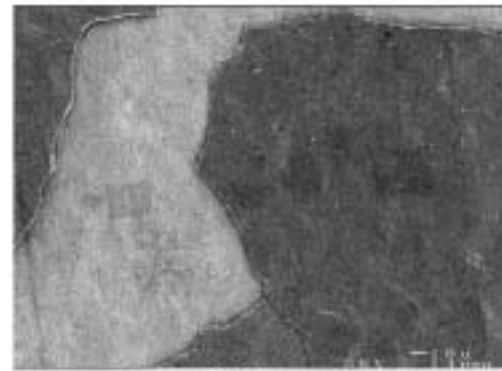
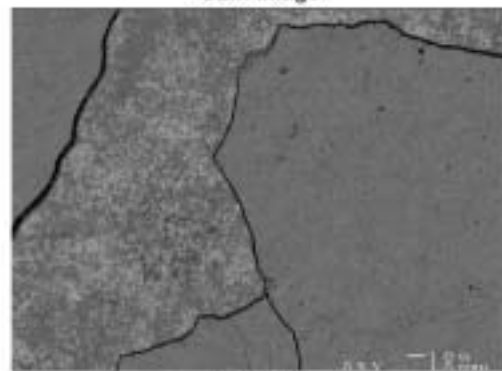
KS-904-6

The ESCA and surface examination results for the 4½" dome were very similar to the 1" dome. The surface showed a dark flaking area with a lighter-colored mottled area (*Fig. 6*). The base material was determined to be titanium for the cross section and surface using 10kV beam (*Fig. 7*). Using a 5kV beam revealed carbon, oxygen, and nitrogen (*Fig. 8*). The carbon peak was higher for the 4½" dome (light mottled area) compared to the 1" dome.

**FIGURE 6:** SEM and BEI images for 4 1/2" dome, showing similar features to 1" dome.

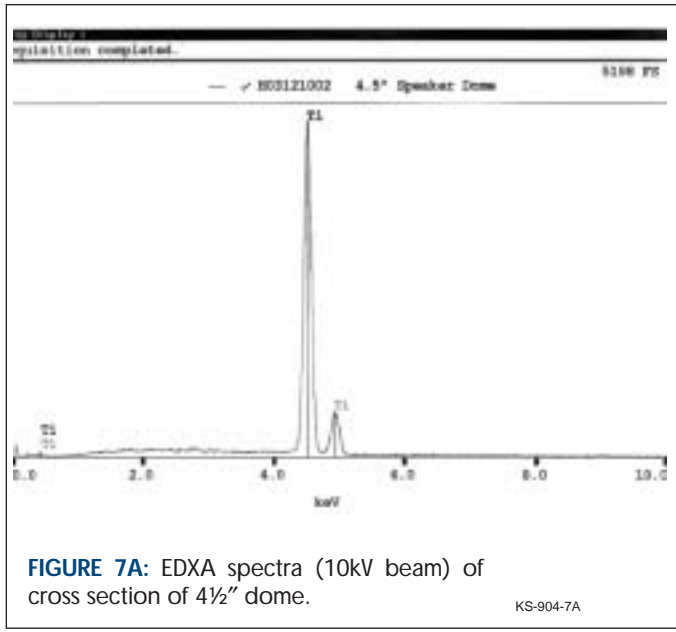
KS-904-7A

FIGURE 7A: EDXA spectra (10kV beam) of cross section of 4½" dome.

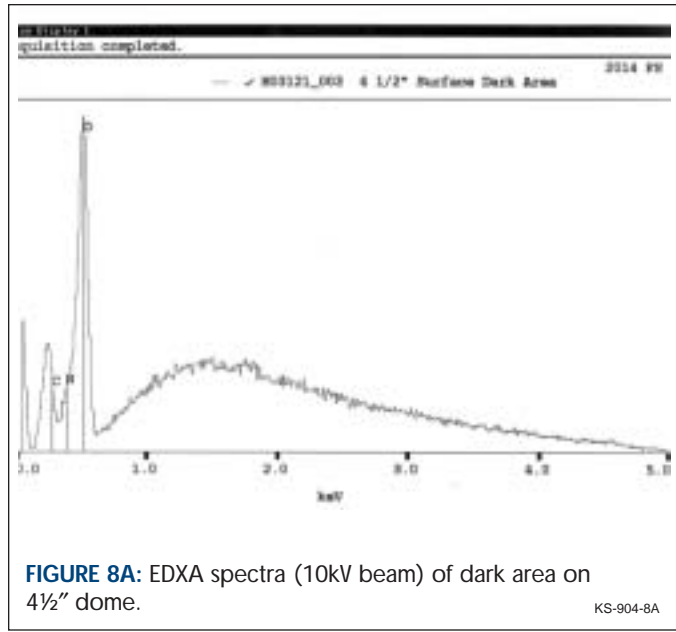
KS-904-8A

FIGURE 8A: EDXA spectra (10kV beam) of dark area on 4½" dome.

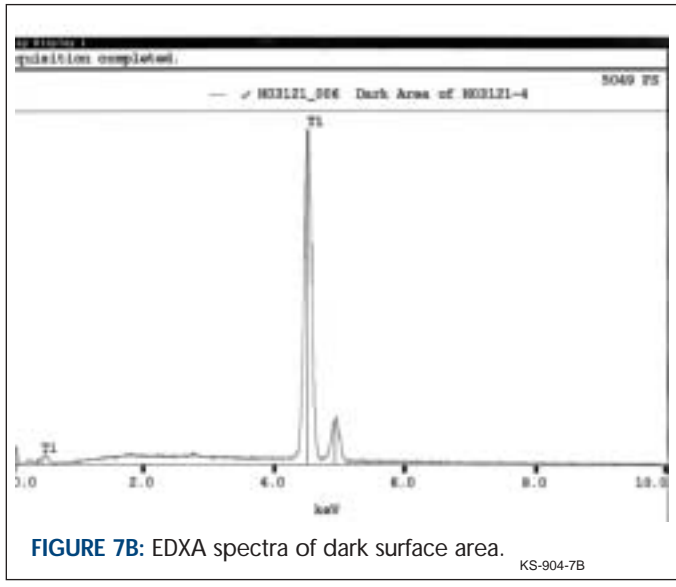
KS-904-7B

FIGURE 7B: EDXA spectra of dark surface area.

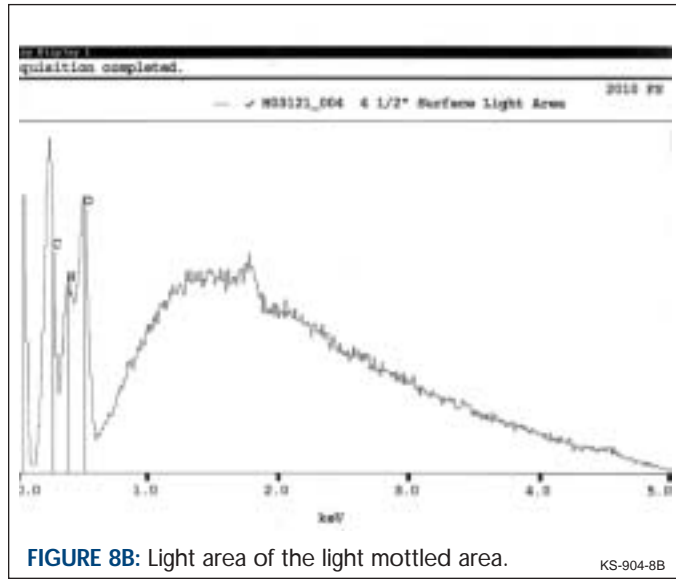
KS-904-8B

FIGURE 8B: Light area of the light mottled area.

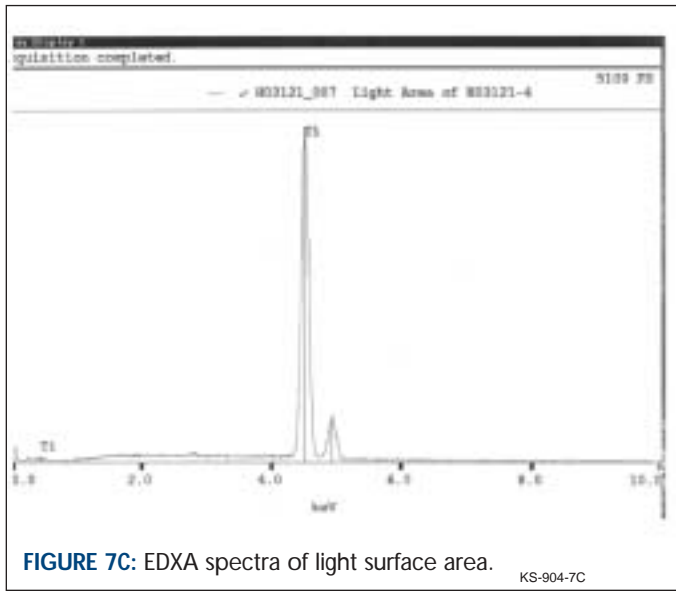
KS-904-7C

FIGURE 7C: EDXA spectra of light surface area.

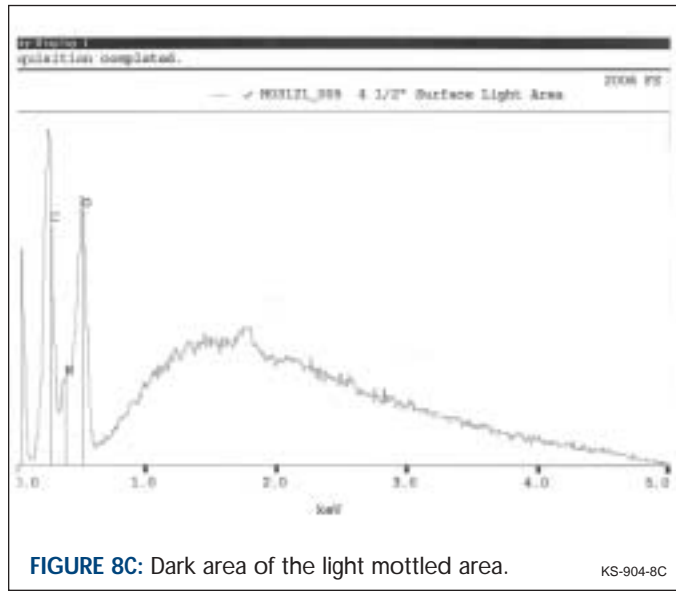
KS-904-8C

FIGURE 8C: Dark area of the light mottled area.
