## POOGE for eBay Test Gear

By Charles Hansen

► How to test bargain equipment you might find on eBay or from surplus equipment dealers.

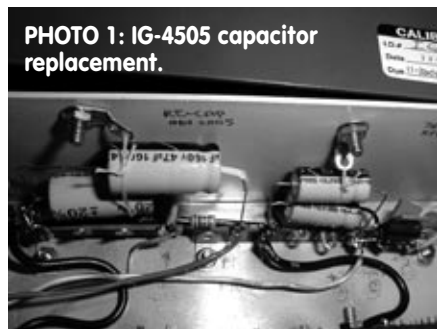
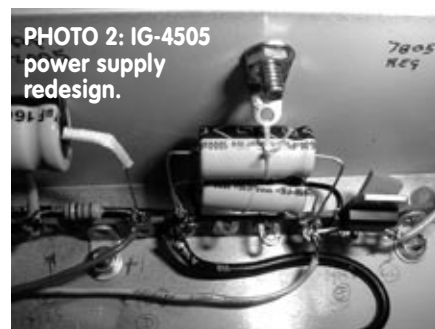
AE-2647-1

I decided to redesign the power supply to use a 78T05 5V regulator IC. This allowed me to remove the power transistor and two extraneous zeners and resistors (R102, R103, ZD101, and ZD102; **Fig. 1** and **Photo 2**). This brought the logic supply up to 4.95V and allowed all the time-base functions to operate properly with a worst-case timing error of 0.2%. However, the raw 7.1V supply at the input to the new 78T05 regulator IC was less than the minimum 7.5V required for good regulation.

FIGURE 1: IG-4505 5V power supply redesign.

The 5V power supply uses a TO-220 regulator power transistor fed from a 7V raw DC supply. The transistor base is connected to a 5.6V zener diode, which should provide the proper 5V at the transistor emitter. The zener had degraded to 4.8V, so the power-supply voltage was insufficient for 7490 decade counter IC2 to operate properly.

My final modification was to replace the power-hungry standard TTL gates with low-power Schottky (LS) equivalents. Circuit Specialists ([www.webtronics.com](http://www.webtronics.com)) has NOS LS gates at nice low prices. I used a 74LS74A in place of the 7474 data flip-flop (IC1) and 74LS90 decade counters in place of the 7490 chips (IC2-IC7). This dropped the total logic supply current from 42mA to 15mA, a savings of almost 900mW. More important, with less load the raw supply to the 78T05 increased to the required 7.5V.
