# PRODUCT REVIEW

## Jensen ISO-MAX Products

Reviewed by Charles Hansen & Edward T. Dell, Jr.

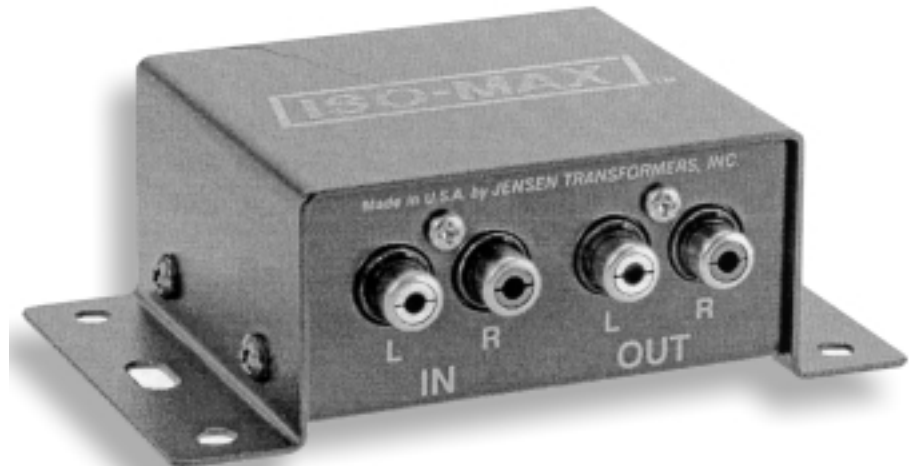
PHOTO 1: ISO-MAX CL2RR dual audio ground isolator.

This is the point at which the Jensen ISO-MAX arrived for review. Working backward from the power amplifier and following the Jensen troubleshooting instructions, I used the isolator and adapters to try to find the source of the left-channel hum. When I installed the Jensen CL-2RR dual audio ground isolator

(Photo 1) between the tube amp and preamp, the hum dropped to an undetectable level in both channels.

#### CL-2RR Dual Audio Ground Isolator

Bandwidth: -3dB at 0.25Hz to 50kHz  
 Input: 7V RMS at 20Hz, 11V RMS at 30Hz  
 Input impedance: 49k when driving typical 47k inputs, 1kHz +4dBu  
 Insertion loss: -1dB max  
 Magnitude response, ref 1kHz: -0.15dB 20Hz min; -1dB 20kHz min.  
 Deviation from linear phase (DLP): ±2° 20Hz to 20kHz, +4dBu  
 Distortion: <0.001% typical, 1kHz; 0.04% typical 20Hz; +4dBu  
 Maximum 20Hz input level: +17dBu min, 1% THD  
 Common-mode rejection ratio (CMRR): typically 95dB at 60Hz, 85dB at 3kHz  
 Output impedance: 4k65, 1kHz  
 DC resistance: typically 2k26 input, 1k90 output  
 Capacitance: 105pF, 1kHz input-to-output  
 Allowable source impedance (driving CL-2RR): zero to 2k  
 Allowable load impedance (loading CL-2RR): 10k min.  
 Allowable load capacitance (cable and circuit loading CL-2RR): zero to 100pF  
 Input to output voltage difference: 24V RMS, 34V peak max.

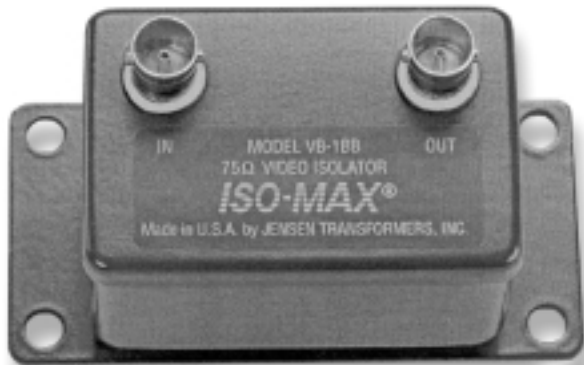
PHOTO 2: ISO-MAX VB1BB video isolation transformer.

I used the VB-1BB baseband video isolator (Photo 2) to try to isolate the problem. Since the VB-1BB has BNC connectors and the cable TV connections use RG/6 coax with F connectors, I needed a set of Radio Shack 278-251 F-to-BNC adapters for some of the tests. For the other tests, I used the BNC-to-phono adapters provided with the Iso-Kit.

#### VB-1BB 75Ω Video Isolation Transformer

Insertion loss: -0.7dB max  
 Differential gain: 0.05% max at 3.85MHz  
 Differential phase: 0.05% max at 3.85MHz  
 Luminance nonlinearity: 0.2% max  
 Bandwidth: -3dB at 10Hz to 10MHz  
 Input VSWR: 1.2 max 1kHz to 8MHz, 1.065 max at 3.85MHz  
 Common-mode rejection ratio (CMRR): 100dB min at 60Hz  
 DC resistance: typically 2.61Ω input and output  
 Capacitance: 1n94, 1kHz input-to-output; 35pF input or output to case  
 Input to output withstanding voltage: 350V RMS at 60Hz

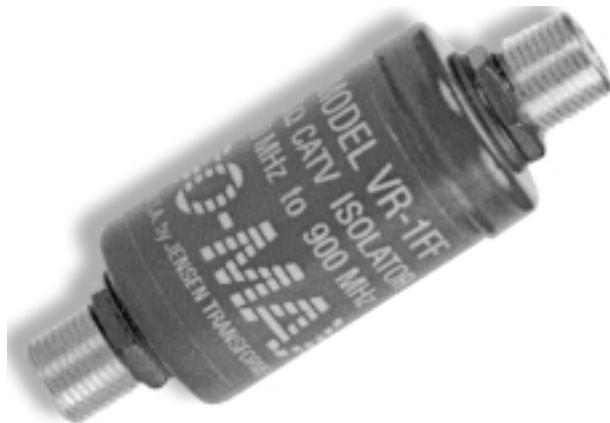
PHOTO 3: ISO-MAX VR1FF CATV ground isolator.

Inserting the VR-1FF single-channel CATV RD isolator (Photo 3) into the 75Ω line dramatically solved the problem with no noticeable signal loss. The manufacturer's speci-

fications indicate that there is a 0.35dB insertion loss. The antenna's gain, however, is strong enough to provide plenty of signal, even at 80 air miles distance from Boston's transmitter farm in Newton, Mass.
